Report on the NEEM 2012 balloon trench experiment.

Copenhagen, 10th September 2012. Jørgen Peder Steffensen, Centre for Ice and Climate, Niels Bohr Institute, University of Copenhagen. (Updated 5th June 2014 and 6th May 2015).

Introduction: At NEEM 2012 an experiment was conducted to investigate the possibility to construct future drilling, science, inclined trenches and overwintering garages without the use of wood as roofing.

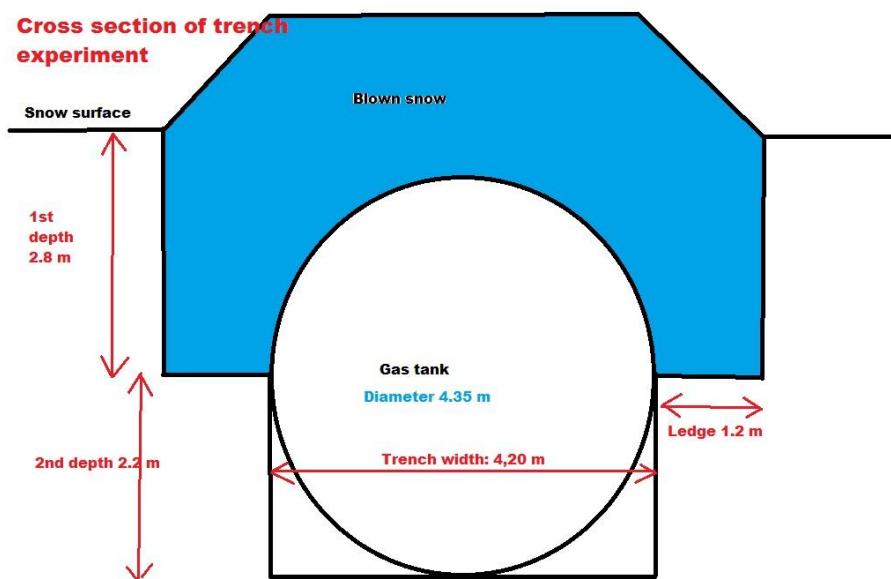
Figure 1: Cross section of the test trench.

In Figure 1 a sketch of the test cross section is shown.

One of the key parameters is the roof thickness versus width of the trench. Going through literature (CRREL reports) and talking to experienced Icelandic glacier drivers, there is a rule of thumb for the capacity of natural snow bridges across crevasses to carry vehicles: The thickness of the snow bridge must be larger or equal to the width of the crevasse.

As seen in the above sketch, this rule is obeyed almost everywhere.

Also, based on observations in the past, we knew that sintered snow from a snow blower does not attach itself well to a vertical wall of undisturbed snow, so in order to make the roof strong and to distribute the load of the roof on a large surface of stronger and deeper undisturbed snow, we included 1.2 m wide ledges along each wall. As an alternative, a wedge shaped (wider at the top) trench could be considered.

As our balloon had slightly different dimensions than shown in Figure 1, we proceeded to adjust our measurements.

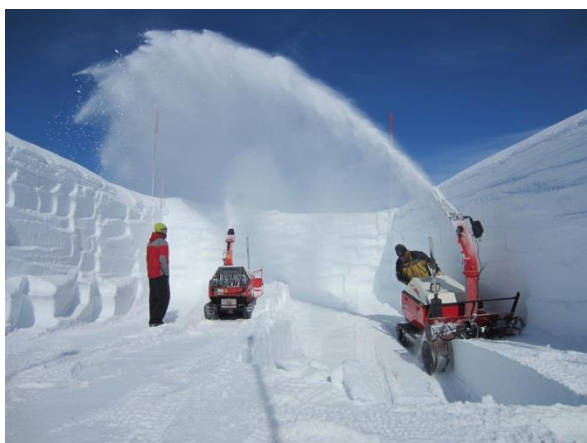
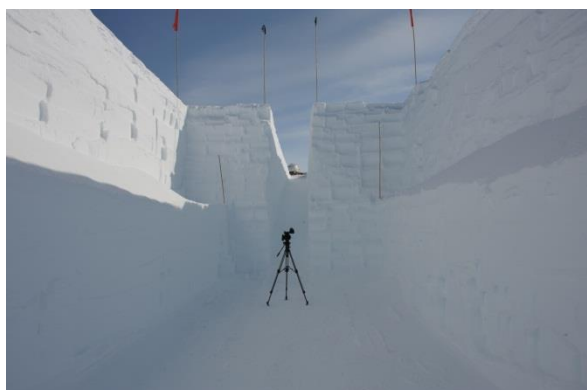
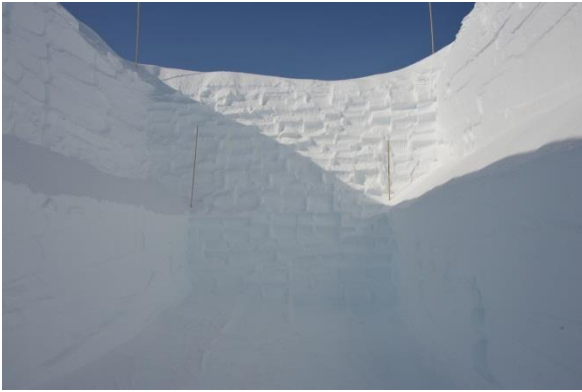
The top part of the trench was a rectangle, 7.0 m wide and 15.2 m long. At one end we marked a 1.2 m wide entrance of the inclined trench in the center. The top part of the trench was excavated to 3.1 m depth using two Yanmar snowblowers.

The bottom part of the trench was 4.6 m wide, leaving a ledge of 1.2 m on each side and 2.2 m deep. Total depth of the trench was 5.4 m.

Excavation began on June 2 and a depth of 2 m was reached. On June 3, the 3.1 m excavation was completed. June 4 the 2.2 m second step was completed.

Observations: As we approached the target depth, it became very difficult to throw the snow over the edge to the surface and a substantial amount of snow fell back into the trench. This was due to the limited reach of the snow blowers and due to the automatic build-up of extra snow along the sides from the blowing itself.

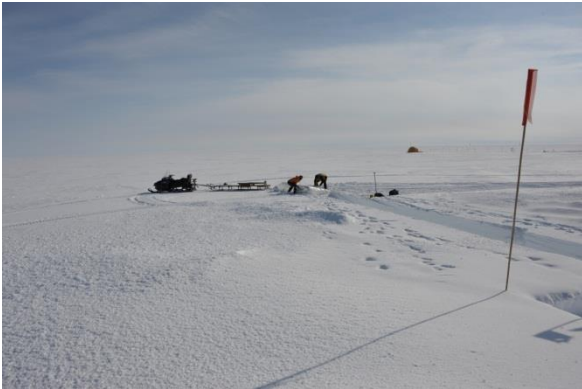
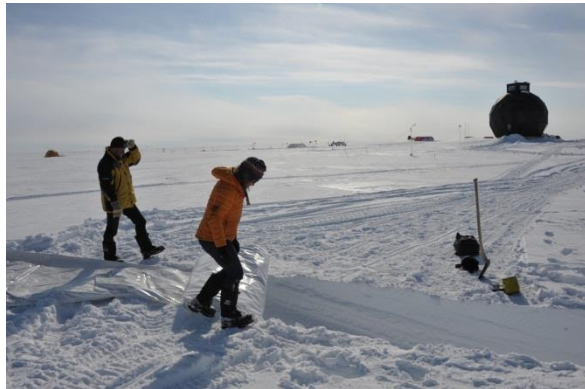
The balloon was inserted on June 4 (this required only two people) and later inflated. Inflation of the 280 m³ air volume took 3 hours.

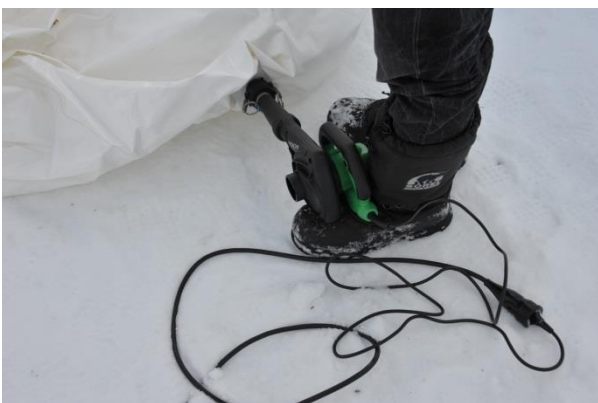
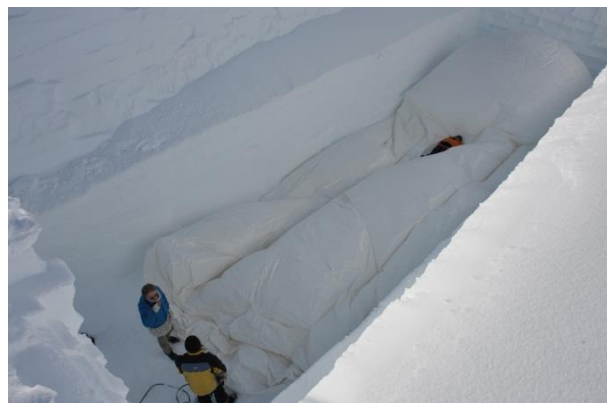
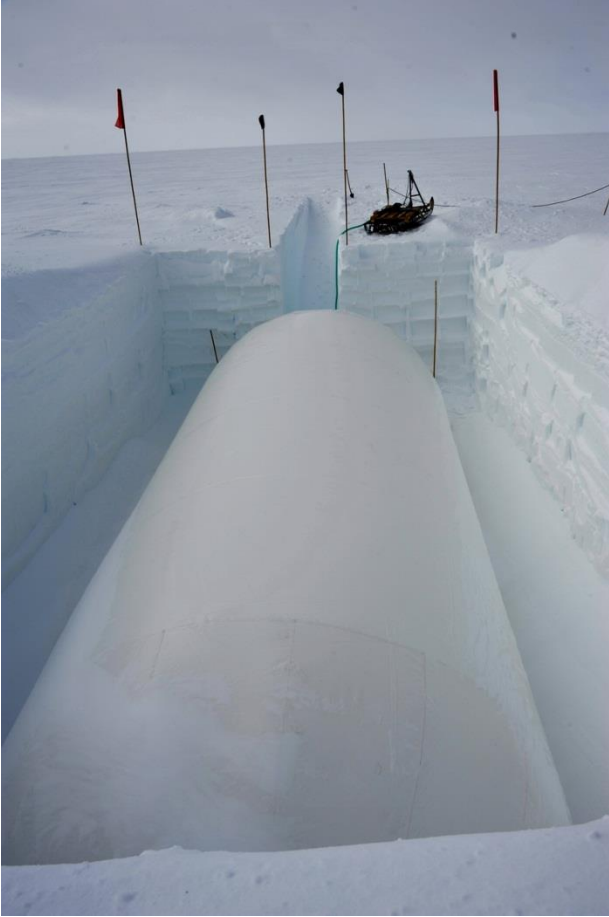
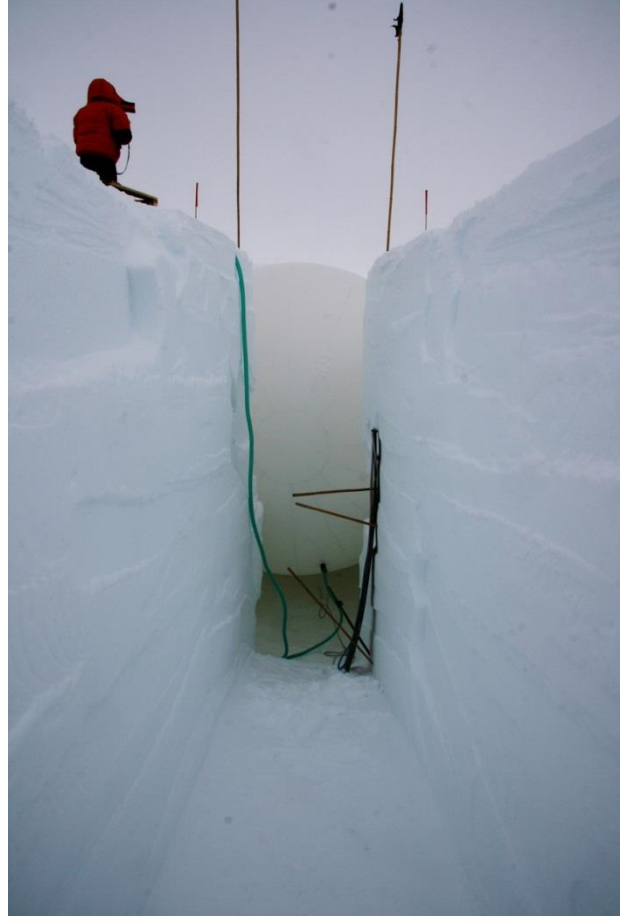
We mounted a clear plastic water hose to the pressure gauge fitting and fixed the other end of the water hose to a plywood sheet in a U-shape. We added an amount of blue glycol solution to the U and drew a scale onto the plywood with a speed marker. As the balloon was guaranteed to hold pressures at 1.1 bar,

we drew max pressure lines at a glycol height difference of 80 cm (taking the slightly higher density of glycol solution into consideration).

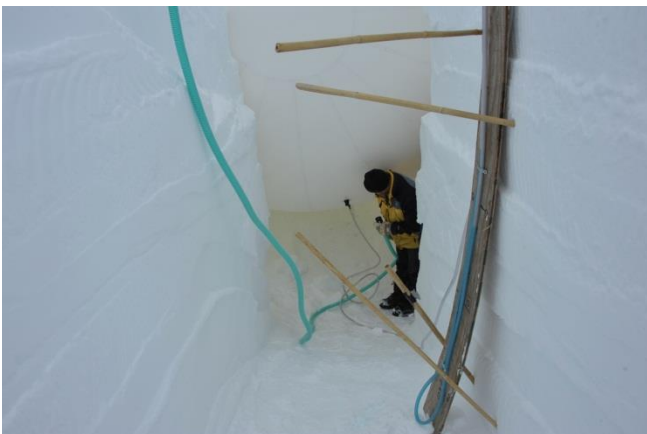
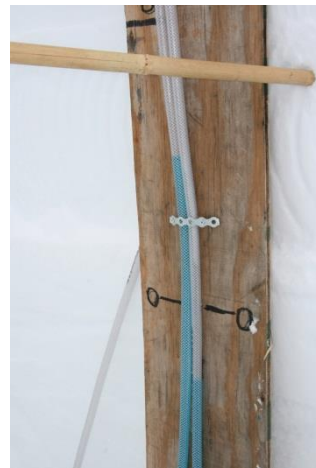
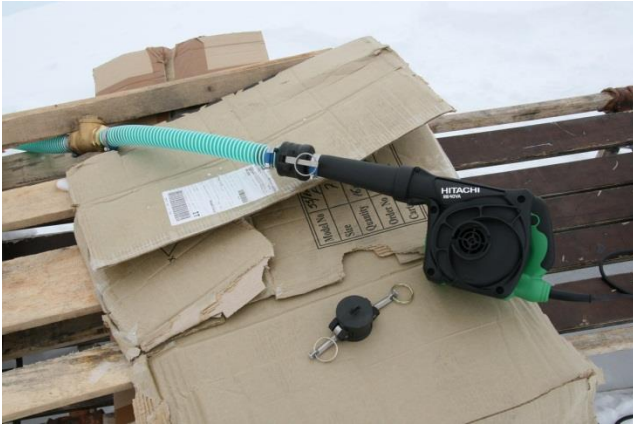
On June 5 we inflated the tank to 75 cm height difference (close to 1.1 bar). At this pressure the balloon was rock hard. We observed that the balloon had “jumped” out of the bottom part of the trench. It was resting on the ledges with the bottom floating some 30 cm over the floor. It was easy to push the balloon along in the trench so that the end pointed into the inclined trench entrance.

Observations: The balloon was supposed to stay put in the bottom trench; but because the maximum diameter of the balloon was 2.425 m over the floor, a depth of 2.2 m was not enough. In the future, the second stage of the trench has to be 30 cm deeper, i.e. 2.5 m deep to make sure the balloon stays put.

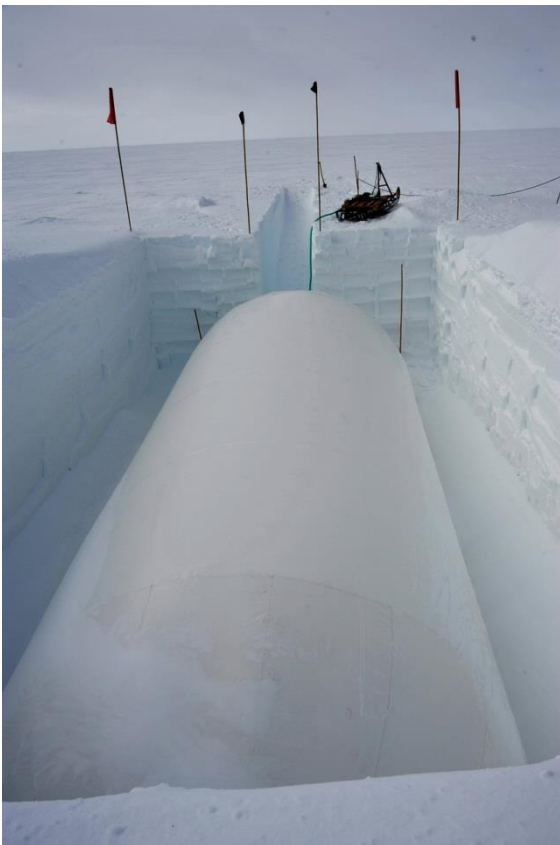
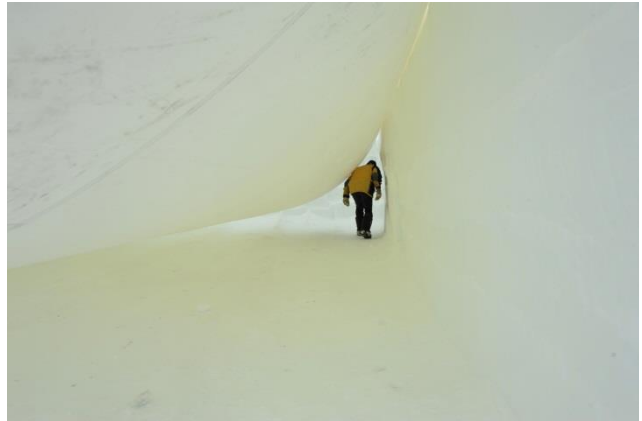
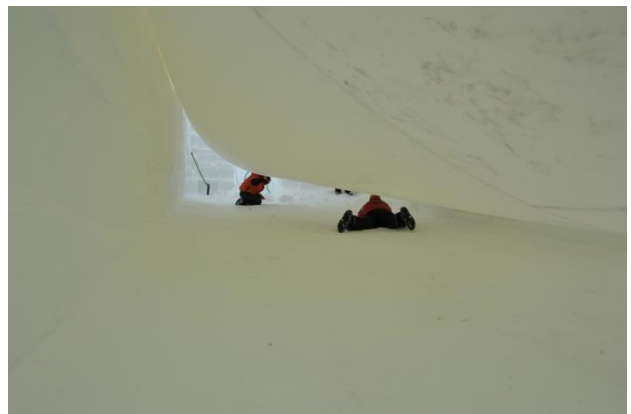
We decreased the pressure to 10 cm liquid level (ca. 1.01 bar) and the balloon dropped to the floor.

During the backfilling of the trench and the following sintering process, we maintained a pressure of 25 cm fluid level (1.025 bar pressure). During the three days of sintering, we could maintain the pressure by running the pump for 2 minutes each 6 hours.

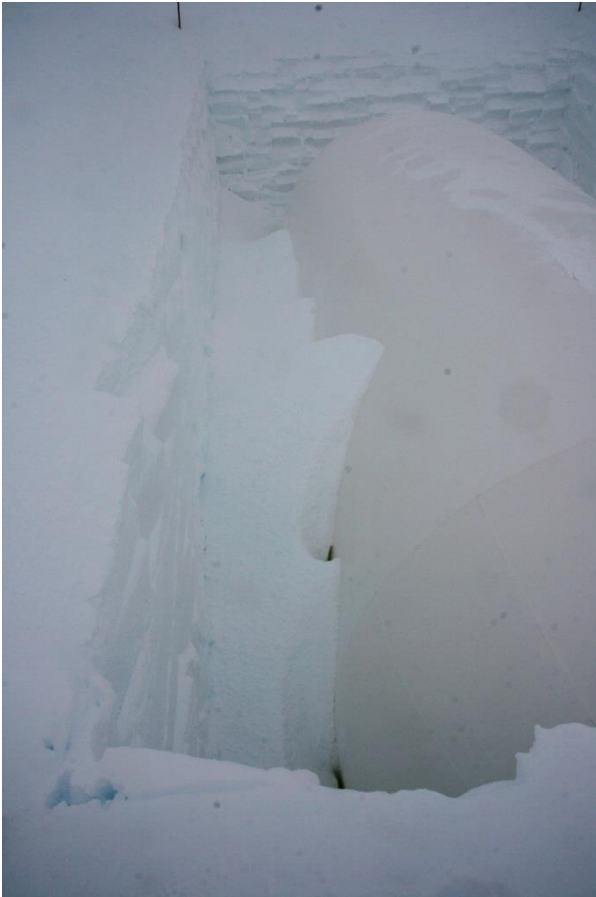
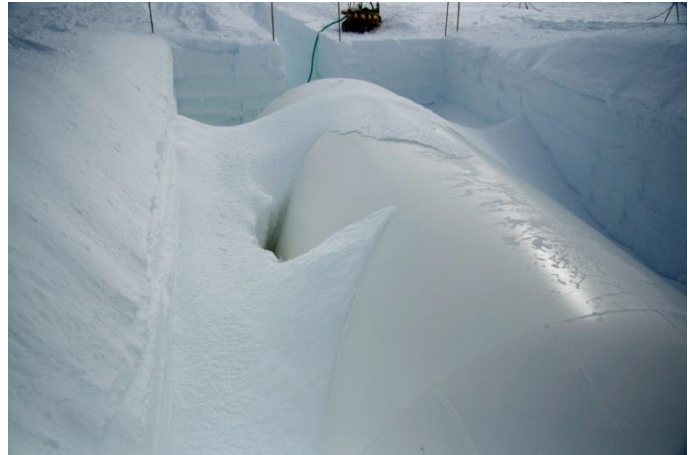
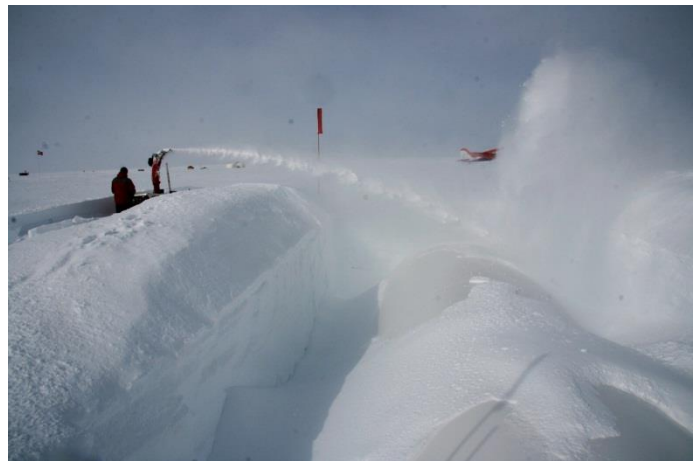
Burial of the balloon and backfilling the trench took two days and was done June 5 and 6. Temperatures these two days were -3 to -6 C. At the end, the roof of the trench was 1 m above the free snow surface.

As the amount of blown snow along the edge of the trench was 1 m thick, we did not blow back the snow closest to the edge of the trench. We left a wall 1 m wide along all sides, both for safety and to increase the volume of the roof.

During the back filling, we ran out of snow to blow back and we had to request snow to be pushed to the site by our Pistenbully. Roughly 1/3 of the snow needed had to be pushed to the site.

Observations: When blowing back, the snow blowers should aim at the opposite side of the trench, blowing snow in a X-pattern.

Several leaks along the sides of the balloon were observed where the blown snow continued to trickle down into the trench. These leaks could not be blocked by just blowing more snow, so a lot of snow fell down below the balloon and created fan shaped stacks of snow in the cave.

Solution: Before backfilling, the sides along the balloon should be sealed manually with a shovel and snow and blocks of snow. Also, increasing pressure in the balloon is a parameter to work with.

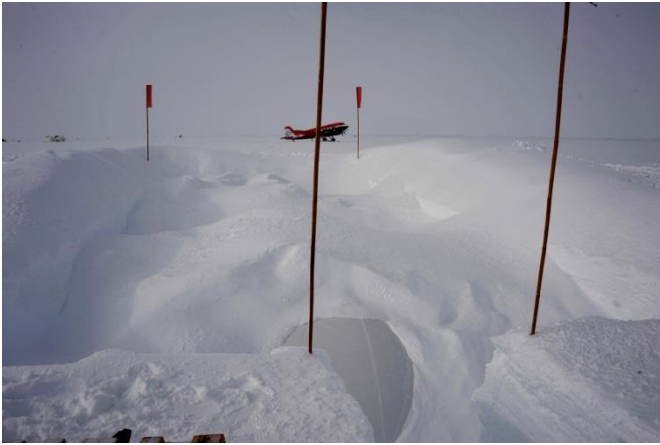
A lot of snow fell down into the inclined trench because we put in vertical plywood sheets too late. In the future we should use plywood sheets with a PVC cover, allowing easy removal of the plywood after sintering.

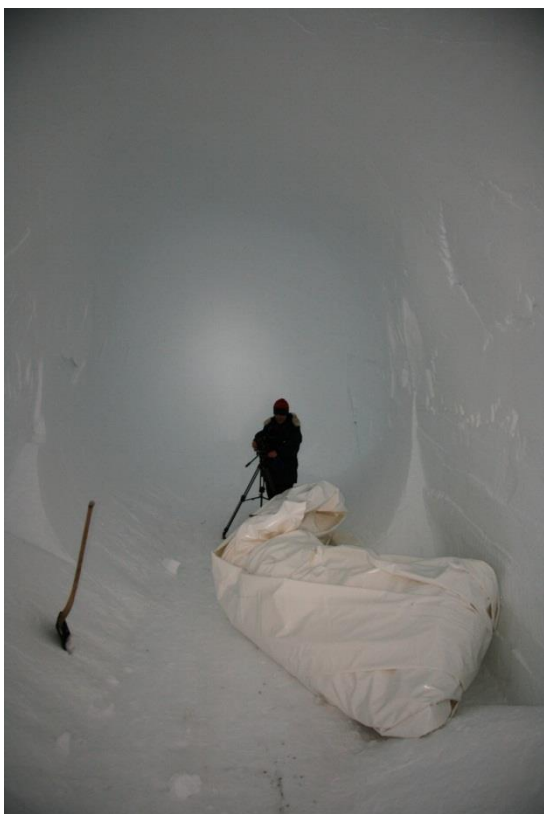
In the inclined trench we began to carefully dig snow away with shovels. As the snow had already hardened somewhat, it became a delicate procedure, because the pressure hose and air hose had to be uncovered without punching a hole in them. As we neared the trench, we could feel the snow getting harder, and the end of the balloon was exposed as the snow around it cracked and fell away. It was possible to put an arm into the space between the balloon and the cast snow wall and slide it all the way around. The balloon was not stuck to the snow wall anywhere.

In the picture to the left the partly folded and deflated balloon is on the floor.

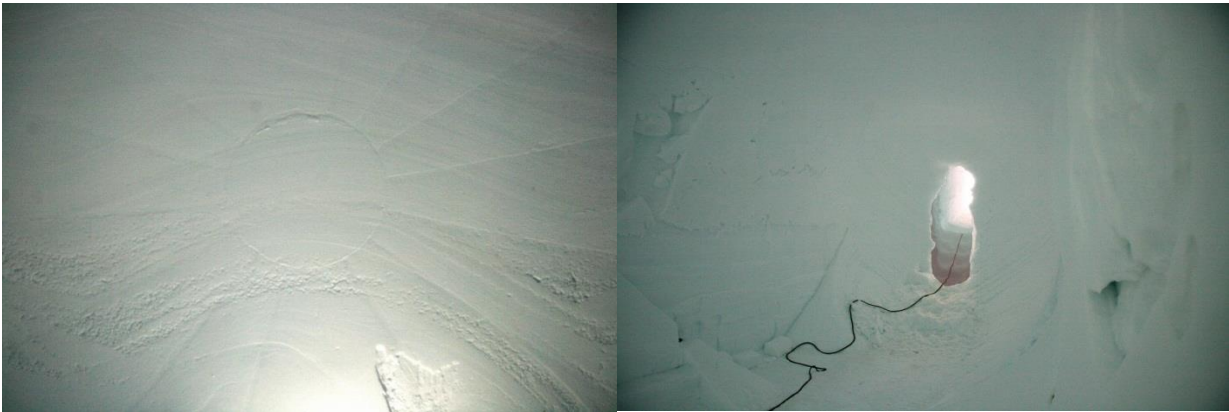
We then enlarged the hole to form an entrance, and it felt like crushing the shell of an egg breaking the inner layers of snow. The exposed trench had the desired shape: A flat floor, vertical walls 2.2 m high and an arched roof. However we were surprised to see the amount of snow that had been leaking down along the sides during back filling. The snow fans reach out from

the walls and give the trench an almost cylindrical appearance. These leaks have to be avoided in the future.

In the pictures above several of these snow leak features are visible as well as the entrance and the far end of the trench where the balloon has left a clear imprint in the sintered snow.

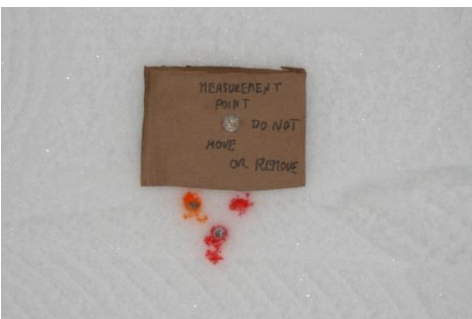
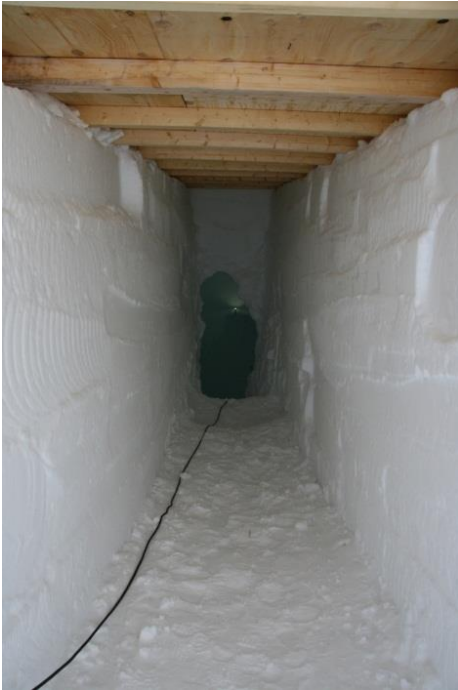
The inclined trench was covered with a roof and terminated with a vertical piece of plywood so that access to the trench is possible in the future. Inside the trench, two sets of three measurement points were setup. One set in the Northern end of the cylinder and one in the Southern end.

South end: Width, 4.48 m, height from floor point to apex of ceiling 4.79 m.

North end: Width, 4.51 m, height from floor point to apex of ceiling 4.60 m.

South end: Width, 4.47 m, height from floor point to apex of ceiling 4.41 m.

North end: Width, 4.50 m, height from floor point to apex of ceiling 4.25 m.

So in 60 days the apex of the ceiling has dropped 38 cm in the South end and 35 cm in the north end.

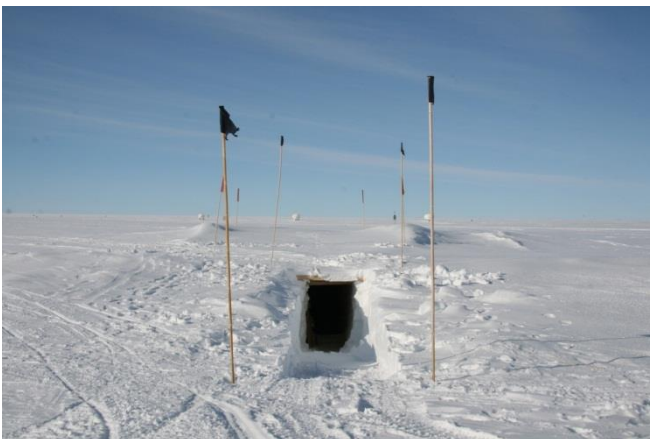
The image to the left shows the final marking of the trench in 2012: Four red flags, one in each corner marks the trench. Four black flags mark the entrance. Two flags are placed at the start of the wooden roof (This is where the vertical plywood sheet is placed). And two flags mark the beginning of the ramp. These flags are for snow blower navigation purposes.

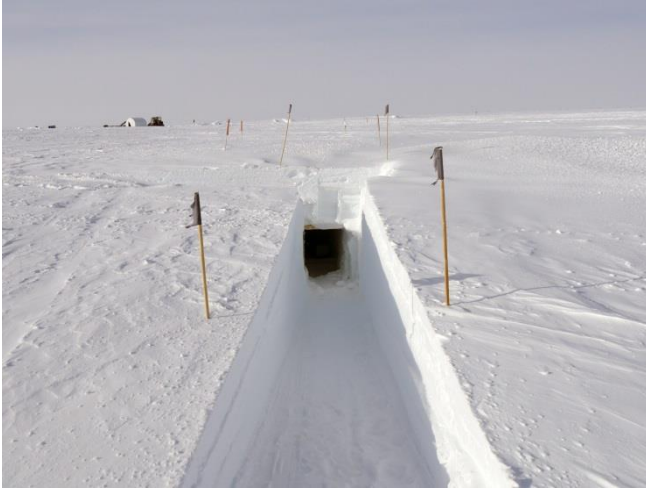
The entrance to the trench in May 2015.

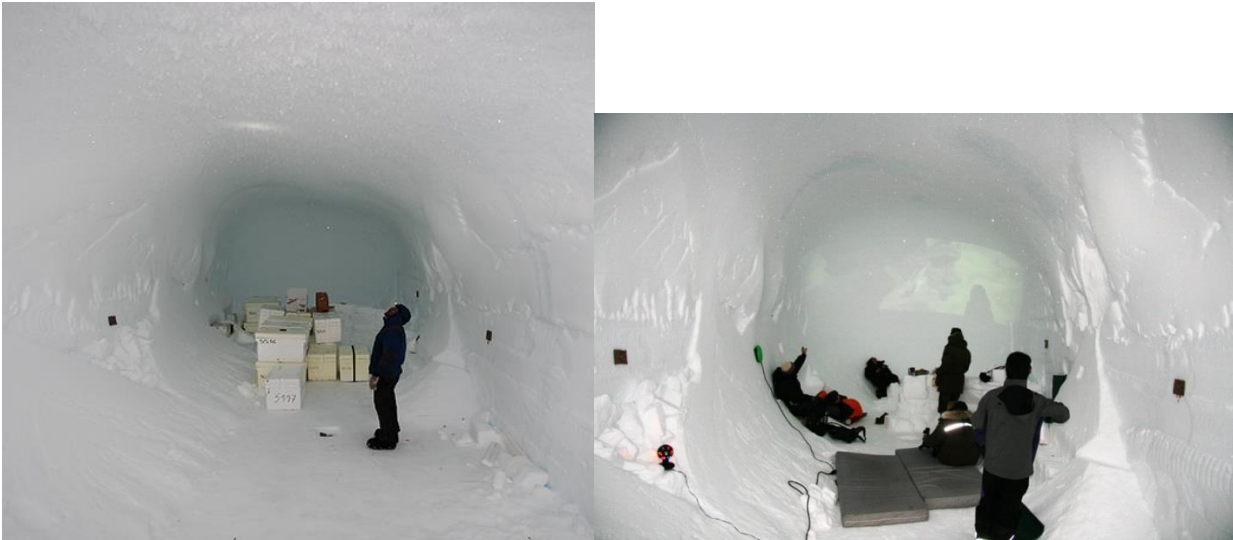
Left: The trench in May 2014. Measurement points to the side and in the floor can be seen. Right: The trench late July 2012.

In both 2014 and 2015, the trench was found in good condition although there is a slight bulge (slumping) in the arch towards the northern end. This slumping was already visible in 2012 as mentioned above. Otherwise the shape has been constant.

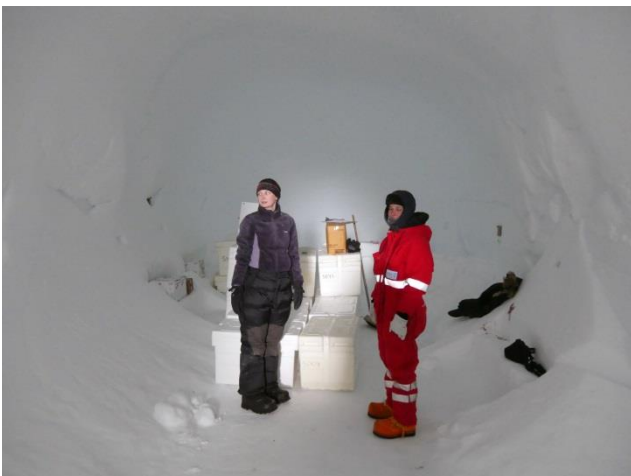
The trench in May 2015.

In May 2015, Paul Vallelonga and Helle Kjær drilled an ice core through the roof and along the side of the roof. The density was measured to 650 kg/m³ (equivalent to a depth of more than 20 m in the firn) and the core was very homogeneous. Sepp Kipfstuhl from AWI plans to analyze a core in AWI's X-ray tomograph.

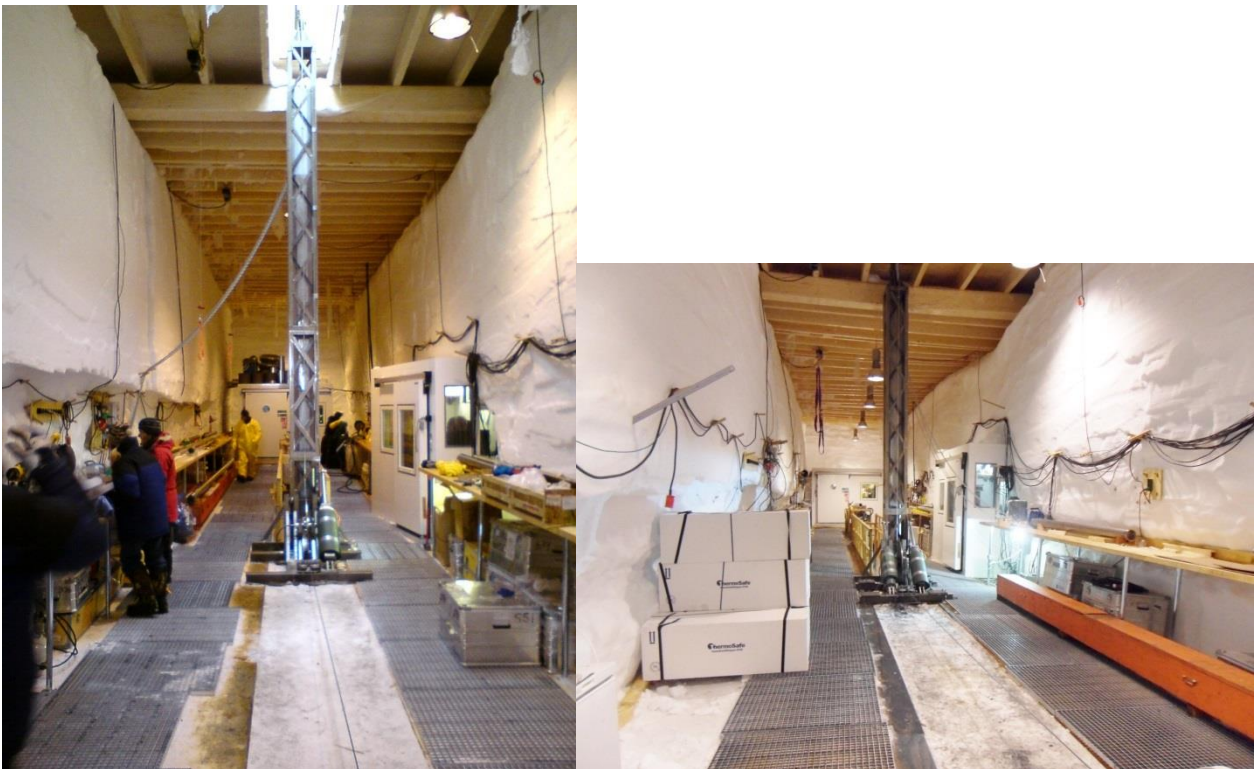
Left: NEEM drill trench June 2009. Right: NEEM drill trench June 2011. Notice the location of the top sheave in the slot in the roof. Between 2009 and 2011 the tower was shortened by 1.5 m (i.e. the section just above the foot of the tower was removed).

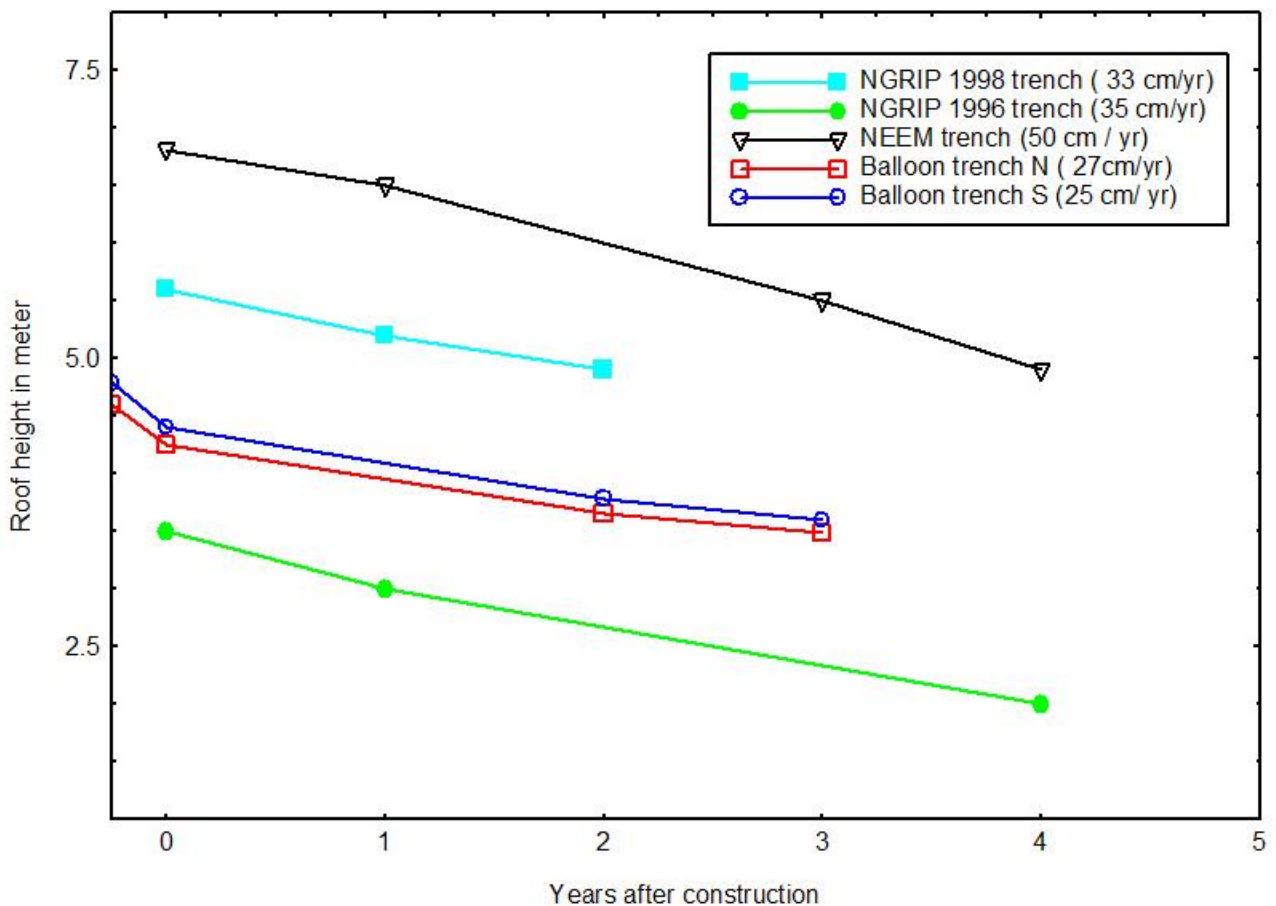
Lowering of roof heights in trenches over time.

This plot shows that the rate of lowering of the ceiling height is 20 % less than that of a conventional wooden roof system. The key number for wooden roofs appears to be 30 – 35 cm/year. **However, between 2014 and 2015, the lowering of the balloon trench was only 17 -19 cm, which is half of the conventional trenches.** The NEEM trench roof has been lowering much faster. This is partly due to the proximity of the main dome causing more than x2 snow accumulation over the trench and partly due to the proximity and

width of the connecting tunnel to the science trench and the weakening of the wall due to the recessed drillers cabin.

Time (years).	Balloon S	Balloon N	NEEM	NGRIP1	NGRIP2
-0.25	4.79	4.6	//m	//m	//m
0	4.41	4.25	6.81	3.5	5.6
1	//m	//m	6.5	3	5.2
2	3.79	3.66	//m	//m	4.9
3	3.60	3.49	5.5	//m	//m
4	//m	//m	4.9	2	//m

The negative times indicate initial slumping in the first few weeks after construction. I have only data from this for the balloon trench.

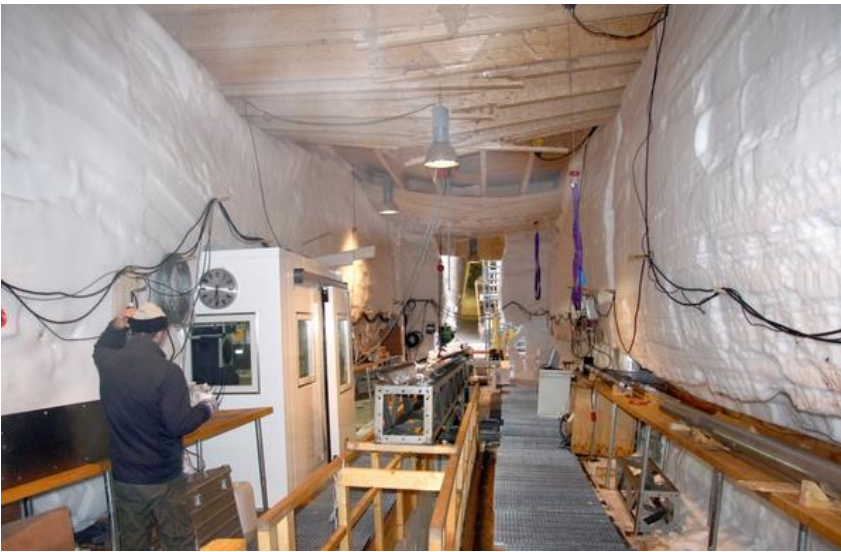
NEEM drill trench in 2012. Note the broken beams.

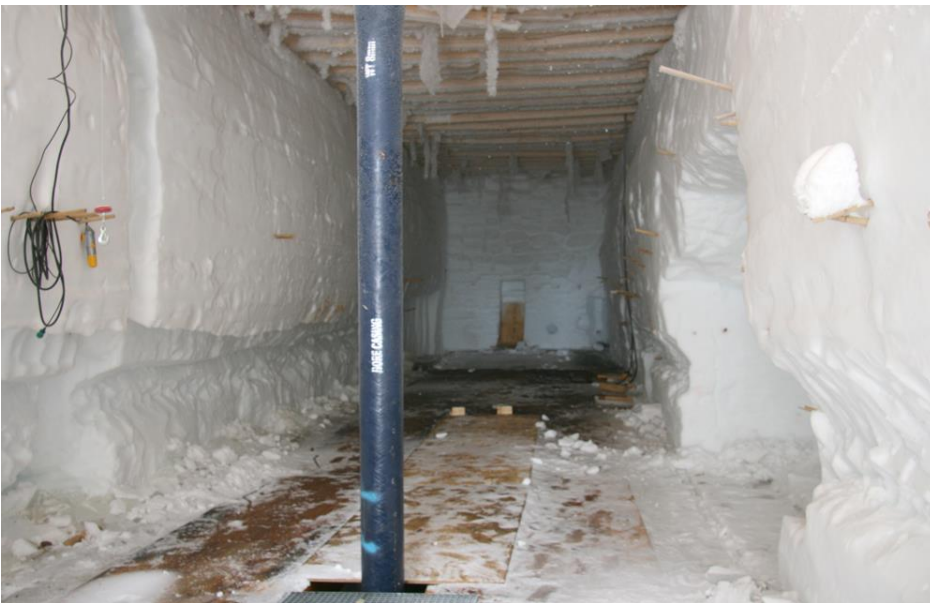
NEEM drill trench with casing pipe extended, just before the trench was back filled in August 2012. All wood in drill trench and science trench had to be abandoned on site.
